Technical Report M10

**SEDIMENTATION STUDY OF THE MISSOURI RIVER,
COPELAND BEND
Miles 569 to 564.5**

HYDRAULIC MICRO MODEL INVESTIGATION

Final Report – September, 1999

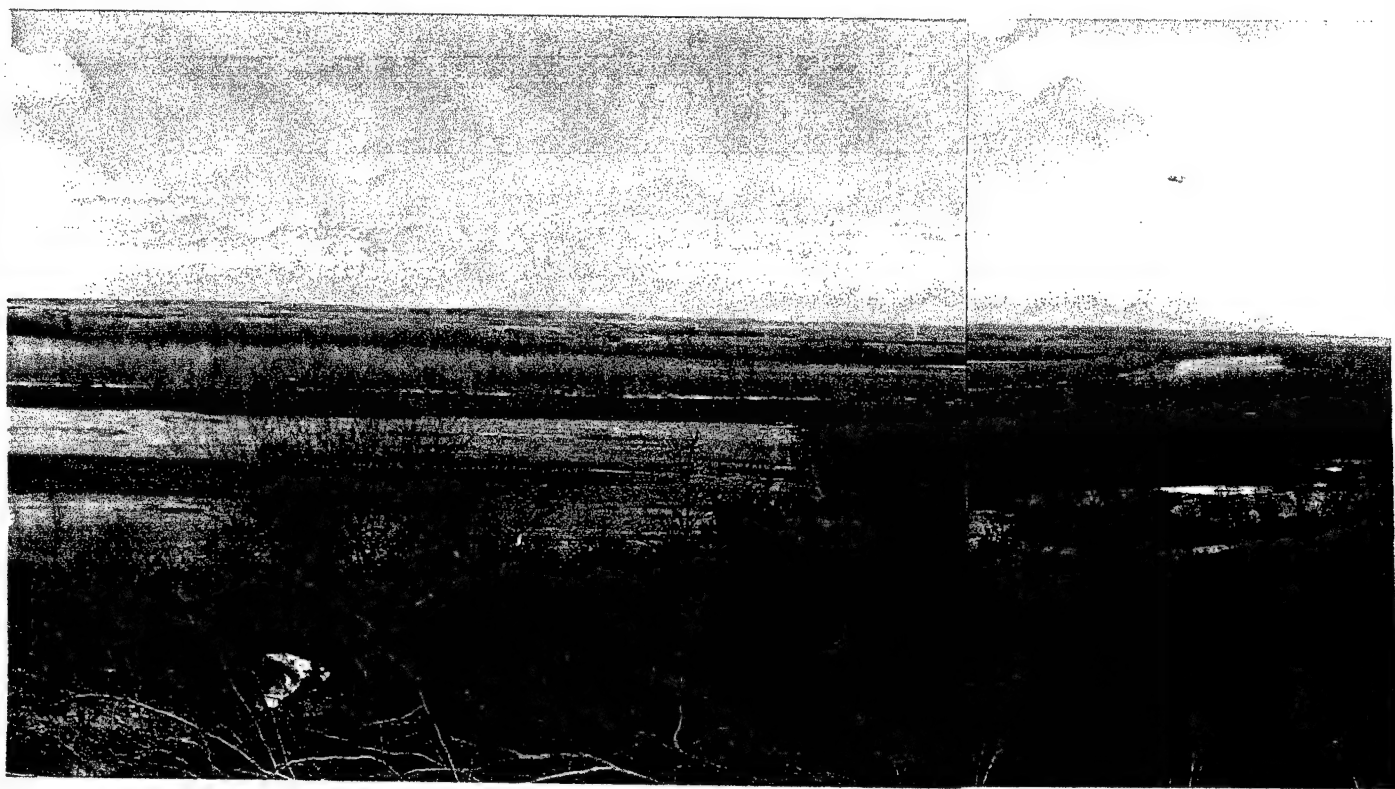
**Copeland Bend, Looking Across the Floodplain Toward
the Left Descending Bank, From Nebraska Bluff**

In December of 1998, river engineers from the St. Louis District made a field investigation of the study reach. Plates 4 through 10 are photographs taken during this inspection. The following observations were noted:

- The downstream parabolic eddy formation generated from each of the dike structures along the inside of Copeland Bend was approximately as long as the spacing between dikes. Generally, it was estimated that the streamwise axis length of each eddy was approximately 3 times the effective length of each dike structure.
- The above observation indicated that the dikes, although not particularly long, were maximizing the available energy of the Missouri River. The dikes were effectively and efficiently protecting the left descending bankline on the inside of the riverbend.
- No excessive erosion was noted along the left descending bankline, indicating that a stable, average contraction width (bank to bank) of approximately 700 feet was being maintained by the dikes throughout Copeland Bend.

- All of the dikes were angled slightly downstream, which has caused small bankline roundouts to occur below each structure. The bankline roundouts appeared to be stable, however, and the integrity of the dikes was not in jeopardy.
- An unusual amount of mature trees were destroyed near and along the left descending bankline due to beaver impacts. This could cause future lateral erosion of the existing bankline.

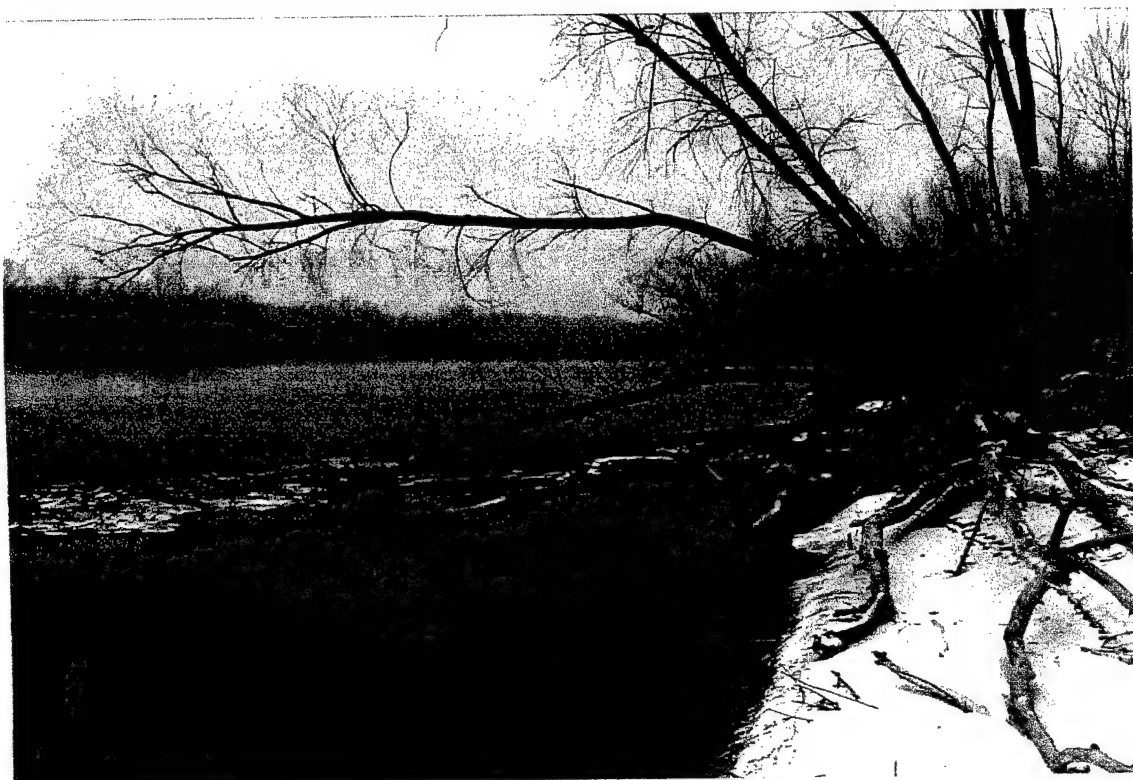
5

Copeland Bend, Looking Upstream at Dike 612.5

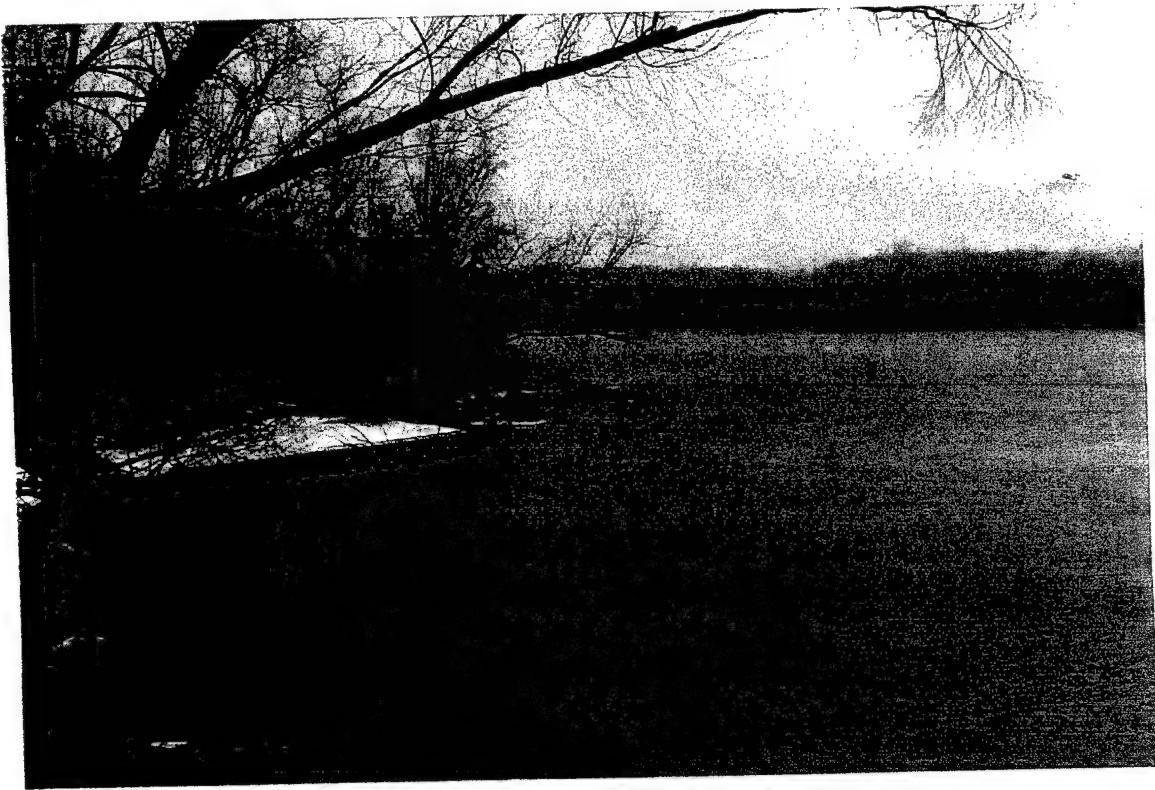
6

Copeland Bend, Looking Downstream At Dike 612.5

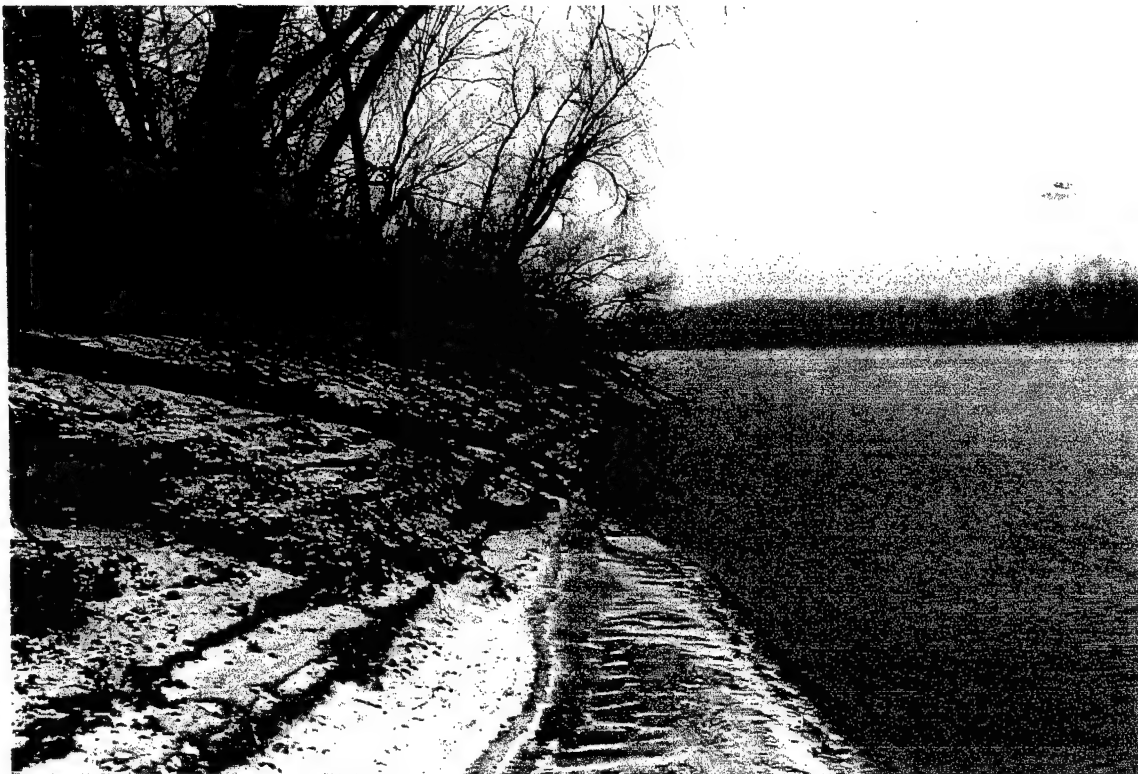
7

Copeland Bend, Looking Downstream From Dike 612.5

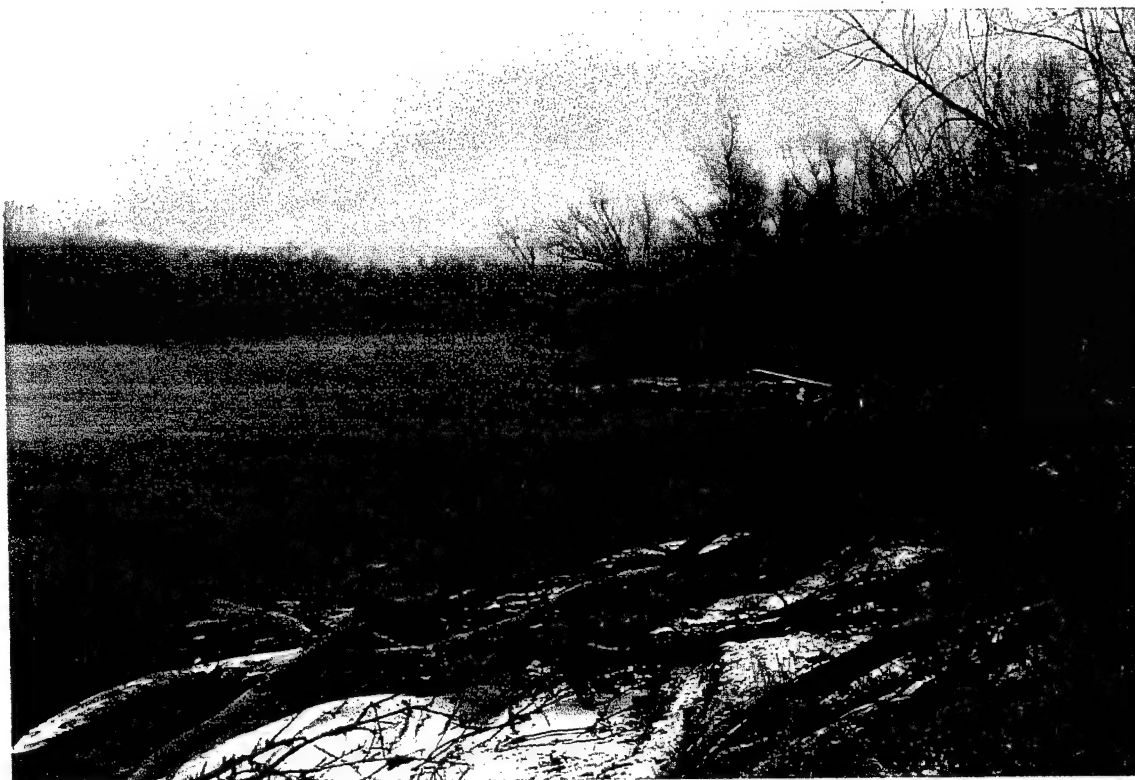
8

Copeland Bend, Looking Upstream at Dike 612.6

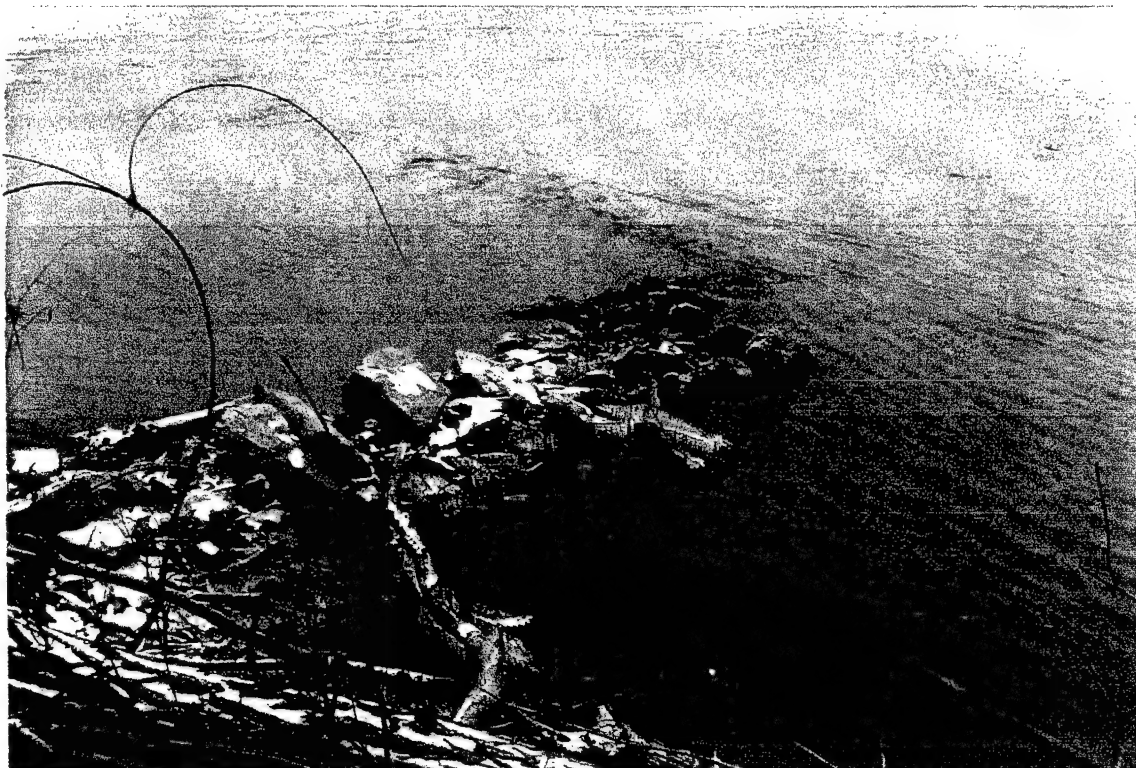
9

Copeland Bend, Looking Directly at Dike 612.6

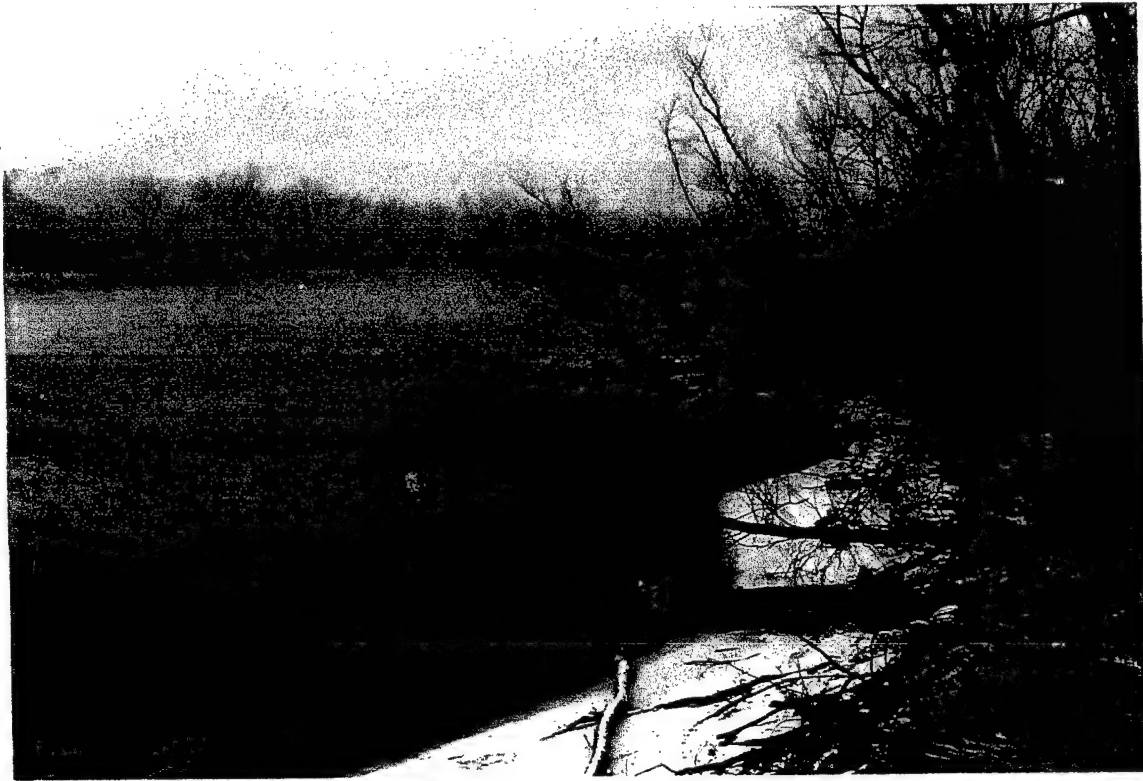
PLATE NO. **10**

Copeland Bend, Looking Upstream at Dike 612.7

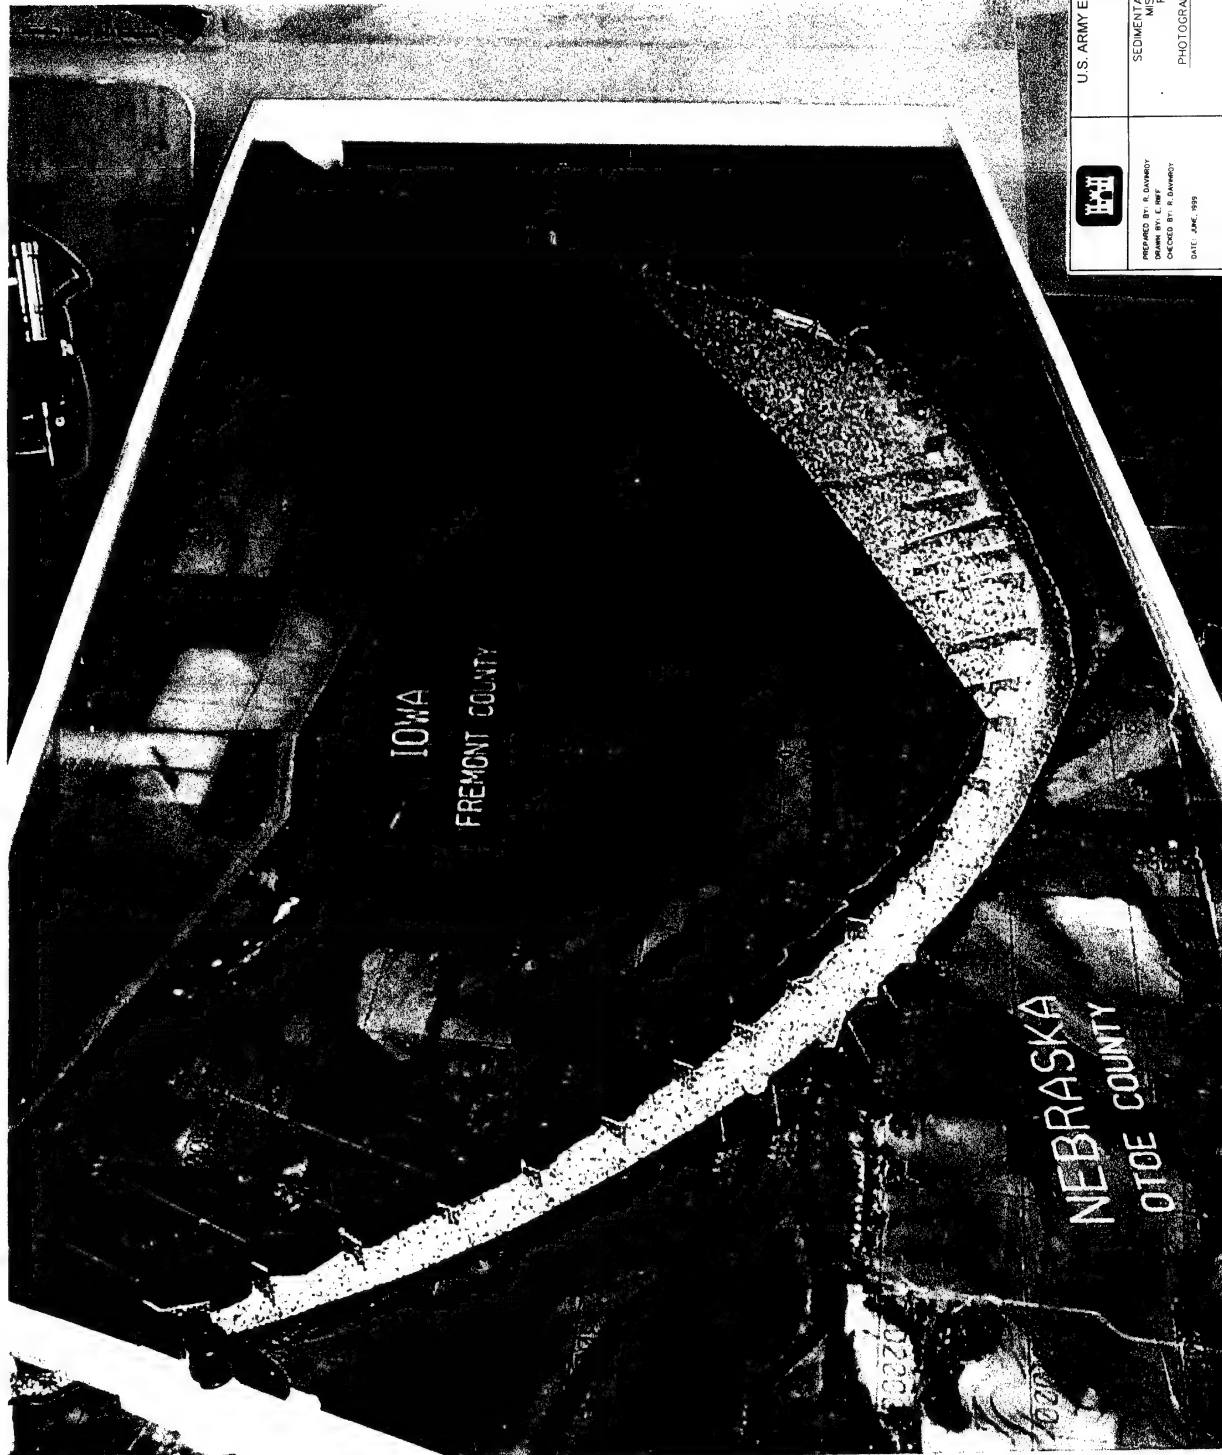
Plate 11 is a photograph of the Copeland Bend hydraulic micro model used in this study. The scales were 1 inch = 300 feet, or 1:3600 horizontal, 1 inch = 20 feet, or 1:240 vertical, for a 15 to 1 distortion ratio. This distortion supplied the necessary forces required for the simulation of sediment transport conditions similar to those of the prototype. Both the bed material and the erodible floodplain section were composed of granular plastic urea, Type II, with a specific gravity of 1.23.

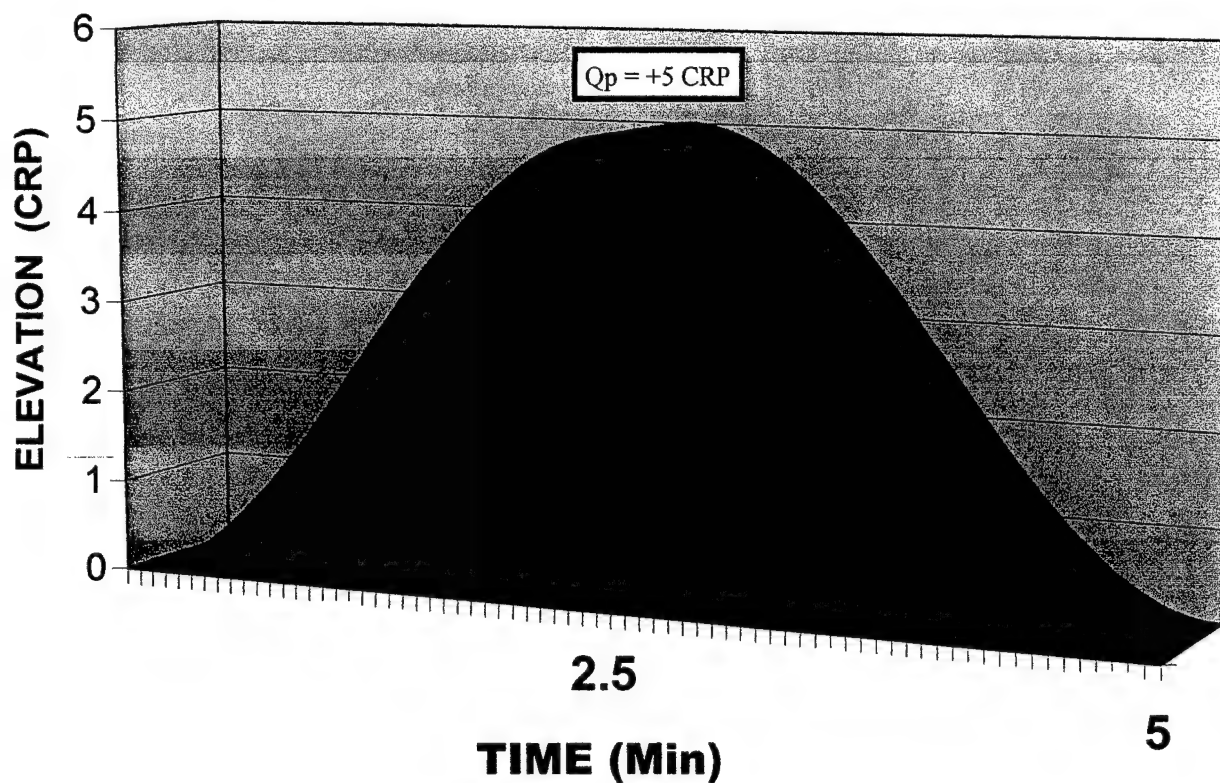
The effective discharge run throughout this model study represented that hydrograph generating an average expected sediment response expected to occur in the prototype. Plate 12 shows the graph of this model hydrograph. Because of the constant variation experienced in the prototype, the effective discharge was used to theoretically analyze the average expected sediment response during any given year. During all testing, the design hydrograph was run successively until stability was observed in both the channel and along the left descending bankline.

It should be realized that because of the nature of the lightweight bed sediment materials that are typically used in movable bed models, hydrographs are not directly scaleable. Thus, in this particular study, although the peak stage of the hydrograph used for testing was at +5 CRP in the micro model, the energy of the model under this condition was representative of much higher flows experienced in the prototype. The design hydrograph then, in simplistic terms, represents an energy condition in the model that effectively enables the model to replicate realistic sediment response conditions similar those observed in the prototype.

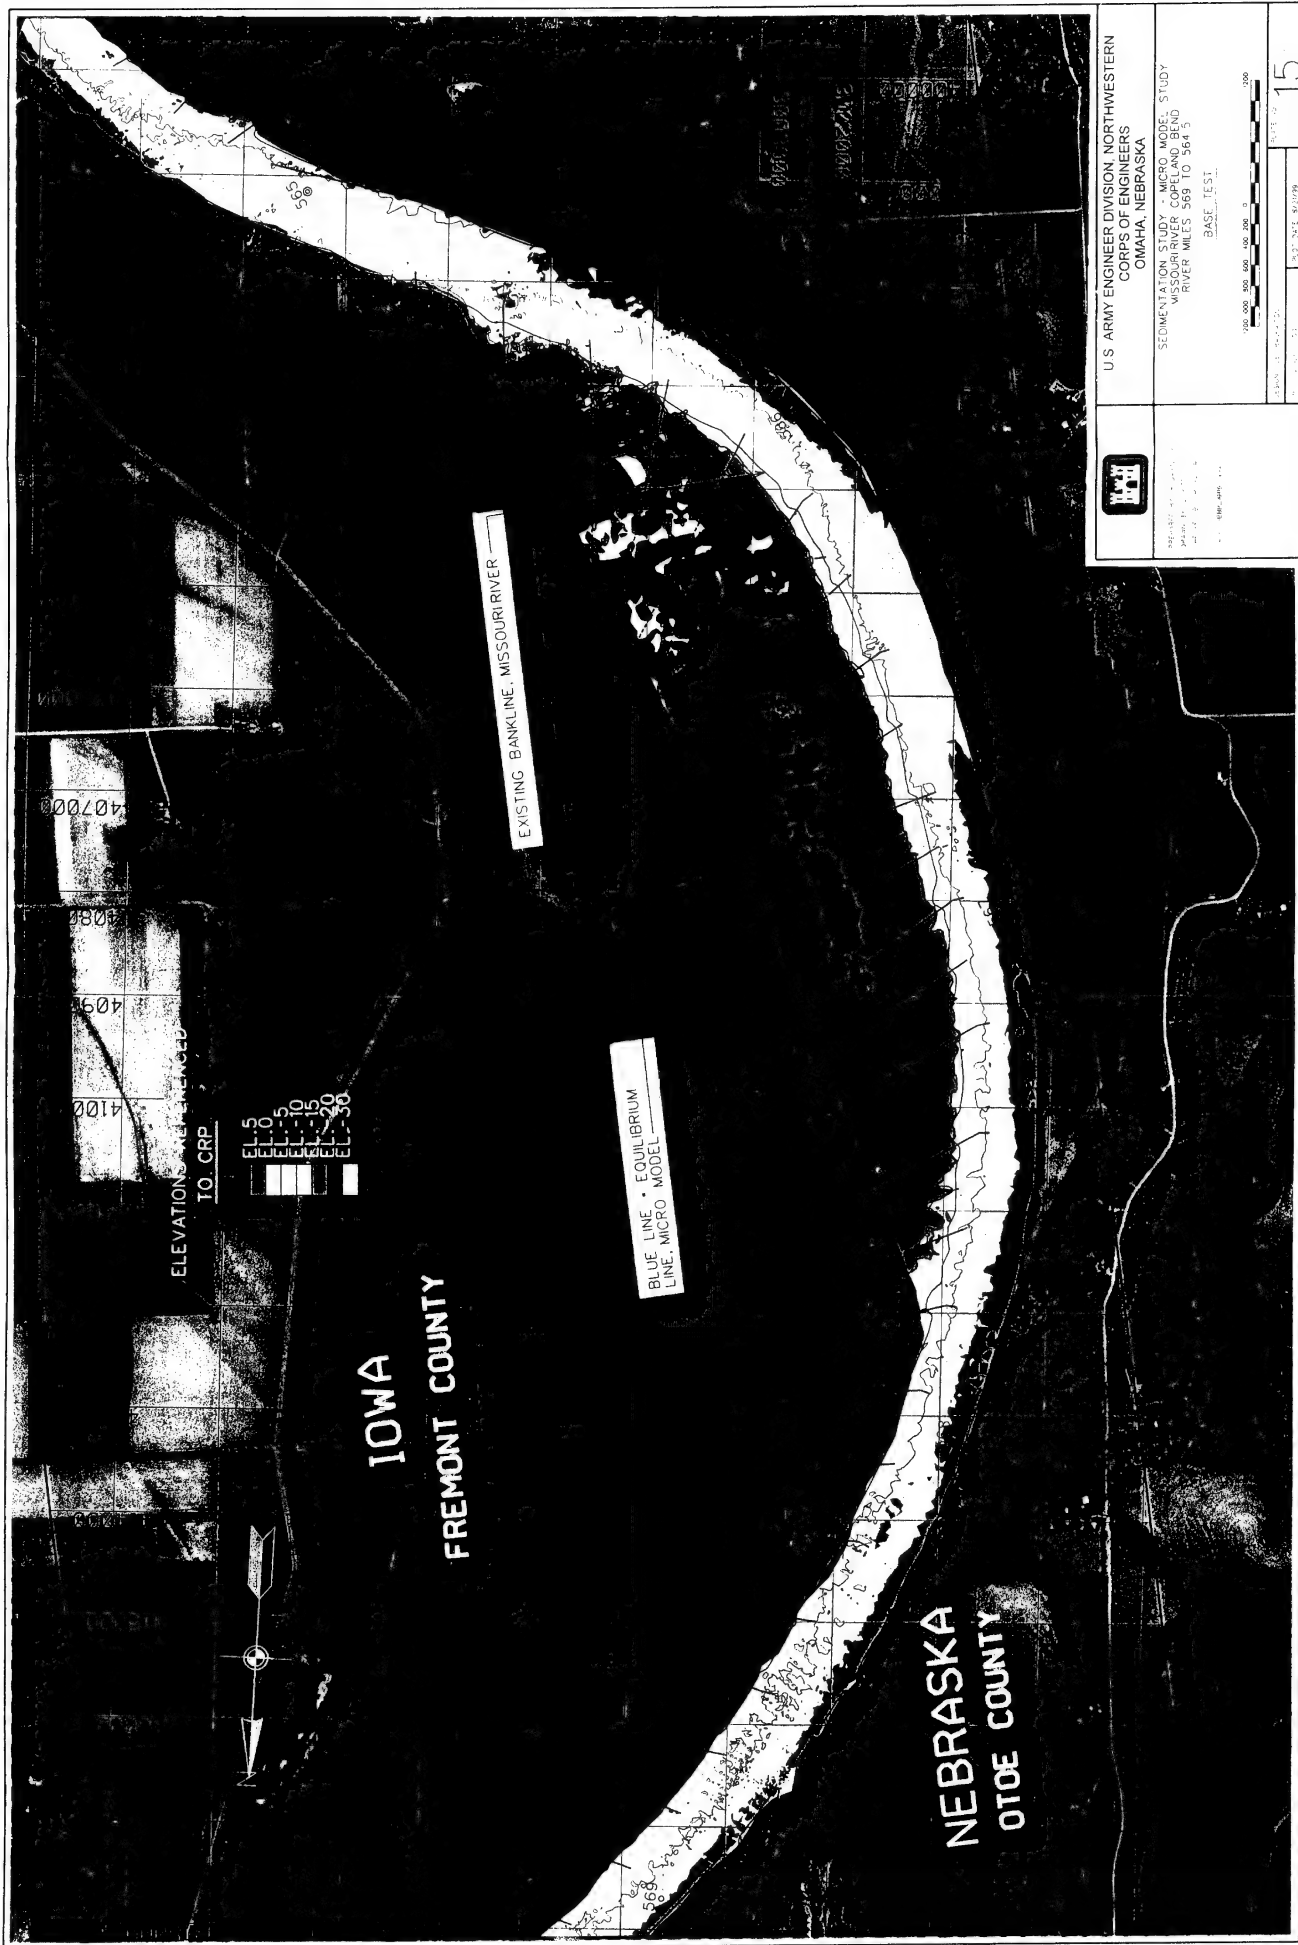
Plate 15 shows the resultant bed configuration of the micro model base test. The base test was developed from the simulation of successive design hydrographs until bed stability was reached and a similar bed response was achieved as compared with the prototype surveys. The observed trends of the model were as follows:

U.S. ARMY ENGINEER DIVISION, NORTHWESTERN CORPS OF ENGINEERS OMAHA, NEBRASKA
	SEDIMENTATION STUDY - MICRO MODEL STUDY MISSOURI RIVER COPELAND BEND RIVER MILES 569 TO 584.5 BASE TEST
<div>0 200 400 600 800 1000 1200 1400 1600 1800 2000</div> <div>0 200 400 600 800 1000 1200 1400 1600 1800 2000</div>	
15

The general bathymetric trends of the base test were very similar to those of the two observed prototype surveys of 1991 and 1996. Generally, the thalweg was located in the same positions as in the prototype. The depositional patterns
